## S E R V I C E B U L L E T I N

**Subject:** Bowler Console Keypad Failures

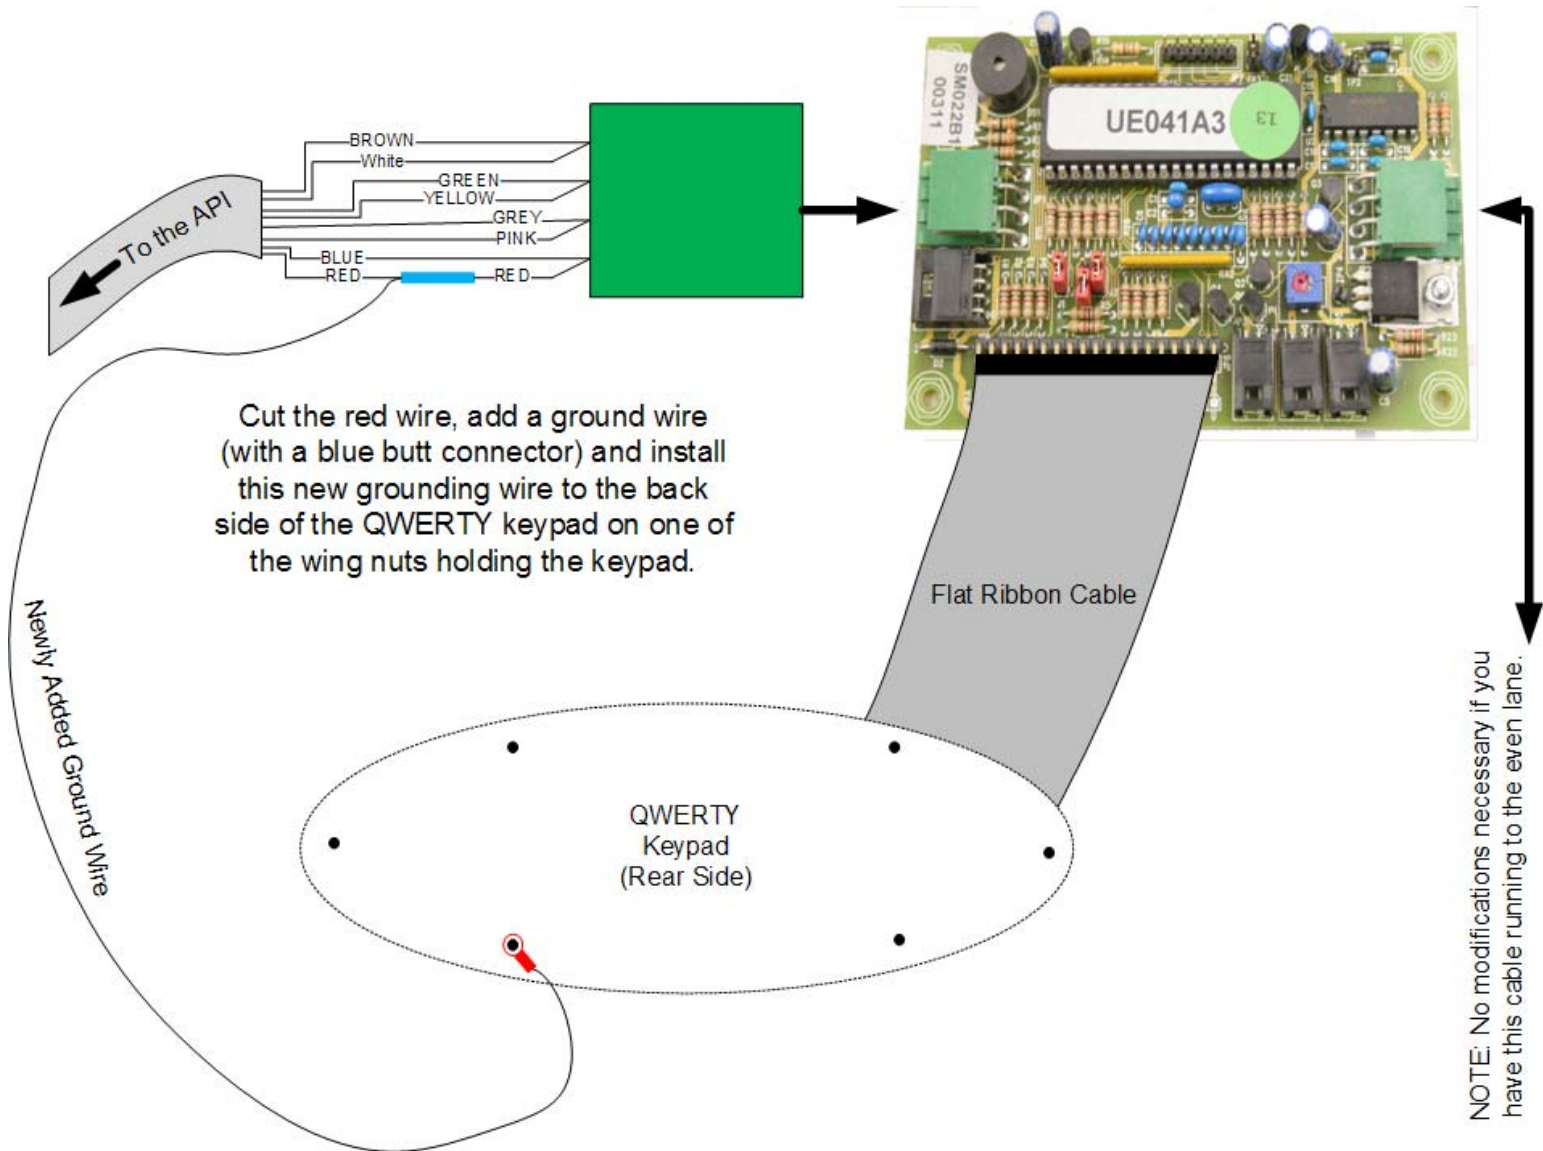
**Issue:** Static electricity can cause the internal PCB to fail

**Description:** When the bowlers are using the keypad, it's possible the static electricity generated by the touch of a finger to the keypad can cause failures.

**Resolution:** A new grounding wire can be added to your existing keypad

Please see the attached diagram for installing a new ground wire to your existing QWERTY keypads
